AS-BUILT FOUNDATION REPORT
AUXILIARY CONDUIT TUNNEL

PARK RIVER
LOCAL PROTECTION

HARTFORD CONNECTICUT

VOLUME II

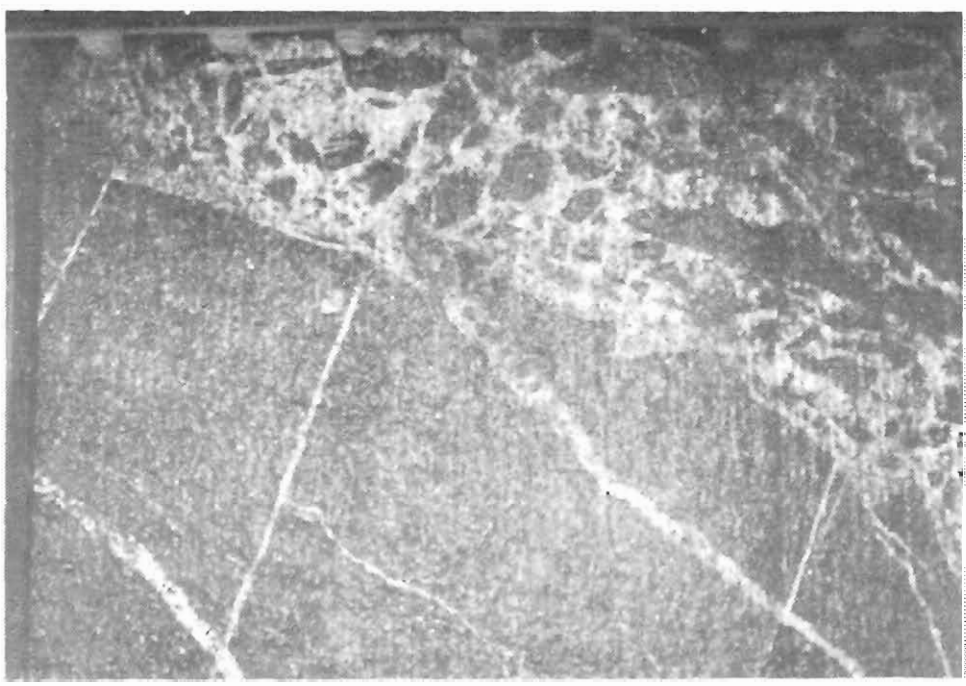
PHOTO I-2 Calcite-healed breccia in contact with gray sandstone. Two parallel calcite-healed joint sets appear within the gray sandstone. Photo obtained at Station 91+32.

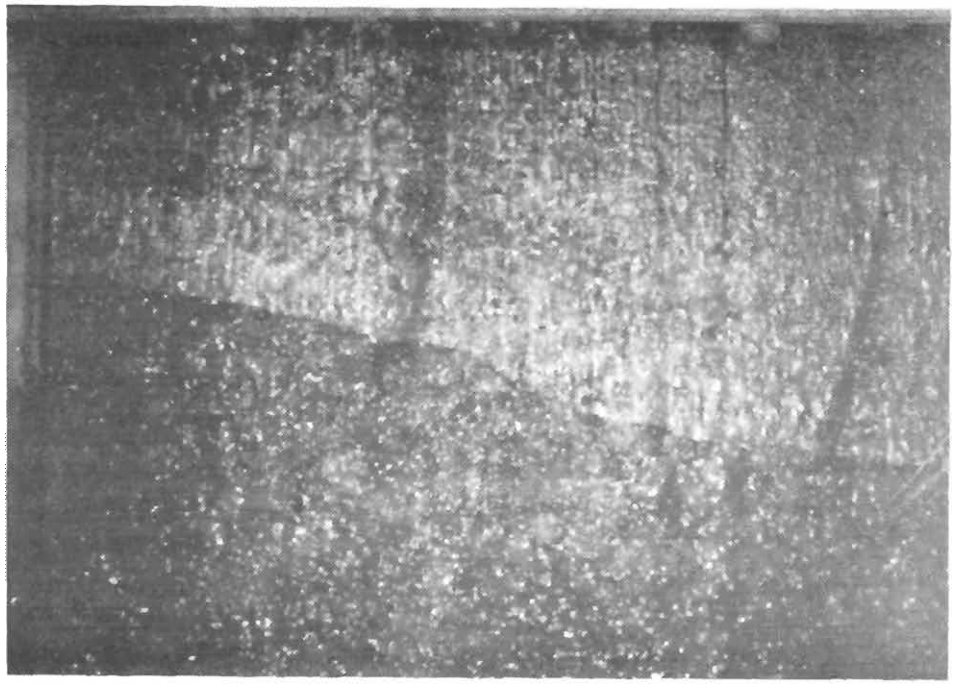
PHOTO I-3 Interbedded sandstone in contact with red shale. Cross-bedded jointing is exhibited within the interbedded sandstone. Photo obtained at Station 38+72.

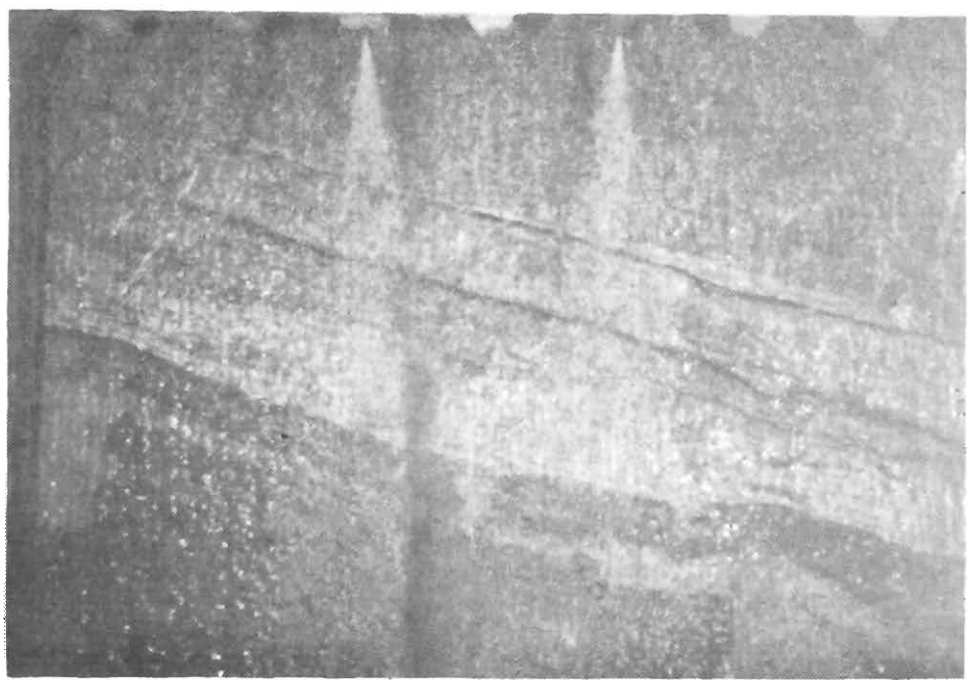
PHOTO I-4 Interbedded sandstone/gray shale in contact with gray shale. The third and fifth water nozzles are spraying water and there is a streak on the glass between camera and exposed bedrock to the left of center on the photo. Photo obtained at Station 65+66.

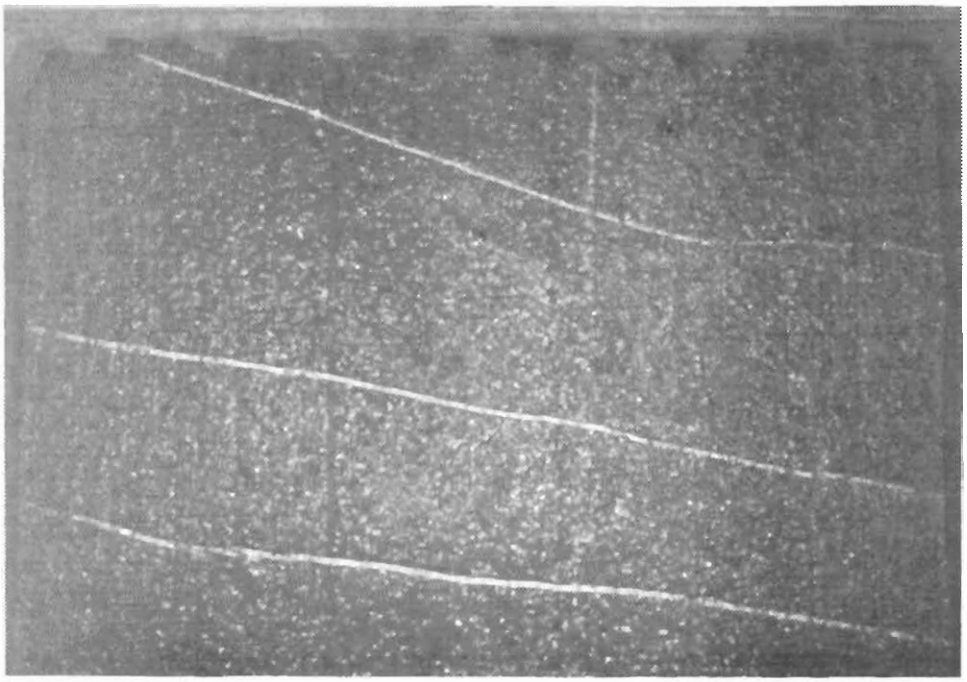
PHOTO I-5 Maroon shale with calcite stringers parallel to bedding. Photo obtained at Station 62+01.

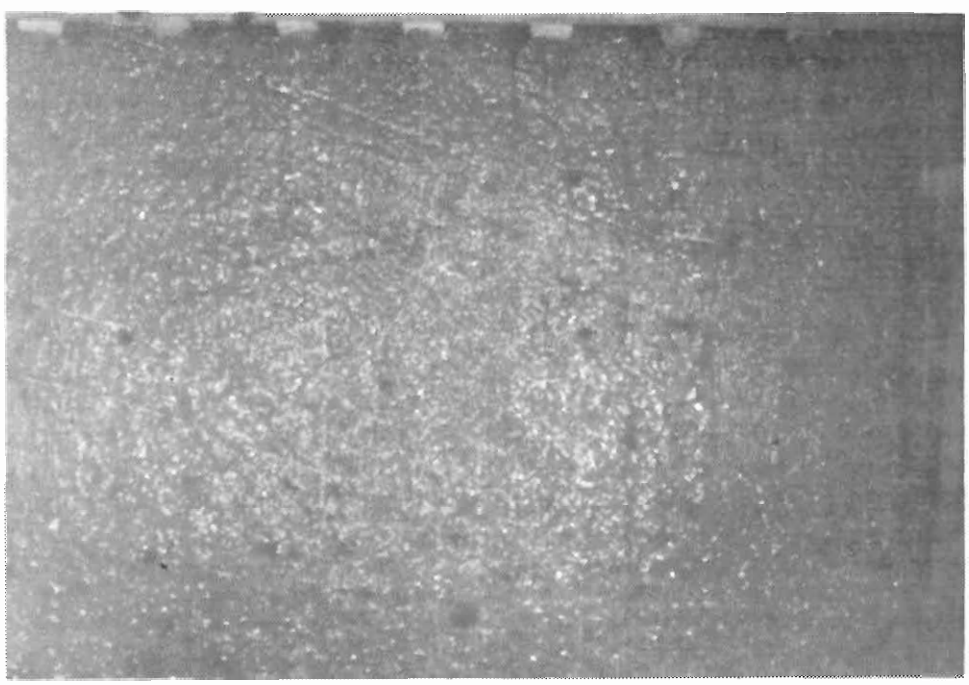
PHOTO I-6 Red sandstone or red shale. Dark spots are accumulated dirt on the glass separating camera and tunnel wall. Photo obtained at Station 53+43.

The maintenance performed on the system during operation primarily involved cleaning the glass window in front of the lens and changing the dessicant in the housing. The glass window separating the front and rear portions of the housing was subject to moisture from the water spray and dust generated during TBM operations. Each time a reference exposure was taken the window would be inspected for any dirt accumulation and cleaned if necessary. The window was cleaned with paper towels from the access opening in the front portion of the housing. Hydraulic pressure to the cylinder operating the outside door was secured by a needle valve to prevent injury from the door opening while cleaning the window. The needle valve also served to regulate the rate at which the door opened and closed during normal operation. Occasionally, TBM cuttings had to be removed from the front portion of the housing.

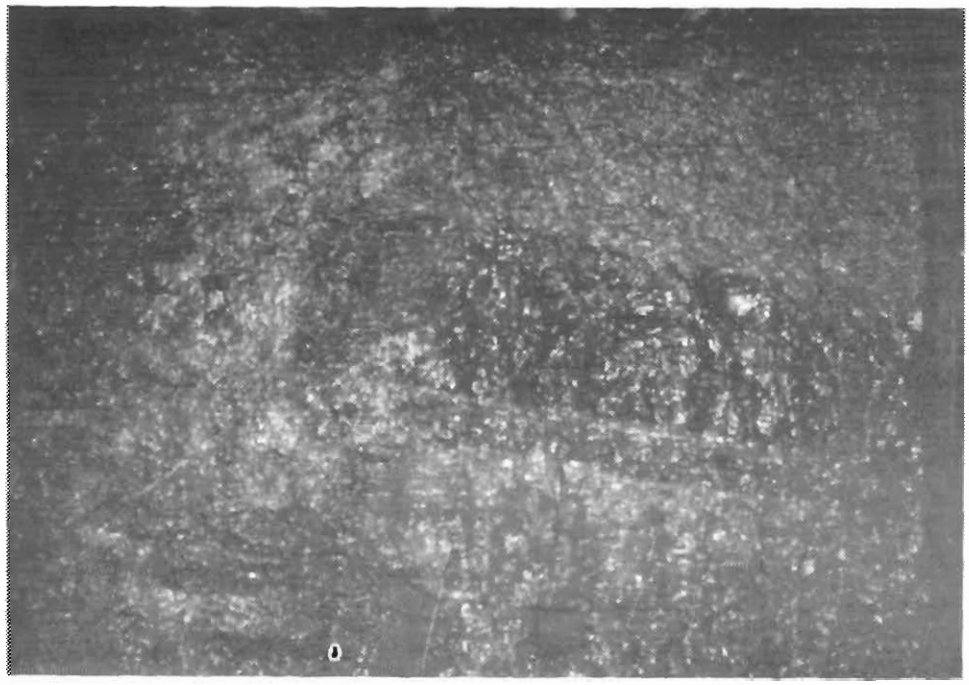
Another characteristic contained in the exposures related to the system used was condensation on the window between the exposed bedrock and the camera, see Photo I-13. It is uncertain whether this moisture was groundwater occasionally present and leaking into the forward portion of the housing or due entirely to the water spray. The exposure appears distorted or out of focus but certain features such as the apparent dip of the bedding are evident. The rock appears to be interbedded with an apparent dip of 15° to 17° to the east; however, the rock type cannot be distinguished.

PHOTO I-7 Gray sedimentary rock (shale or sandstone) with darker interbeds, probably gray shale. The glass separating the camera and tunnel wall appears to have condensation on it. Photo obtained at Station 21+66.

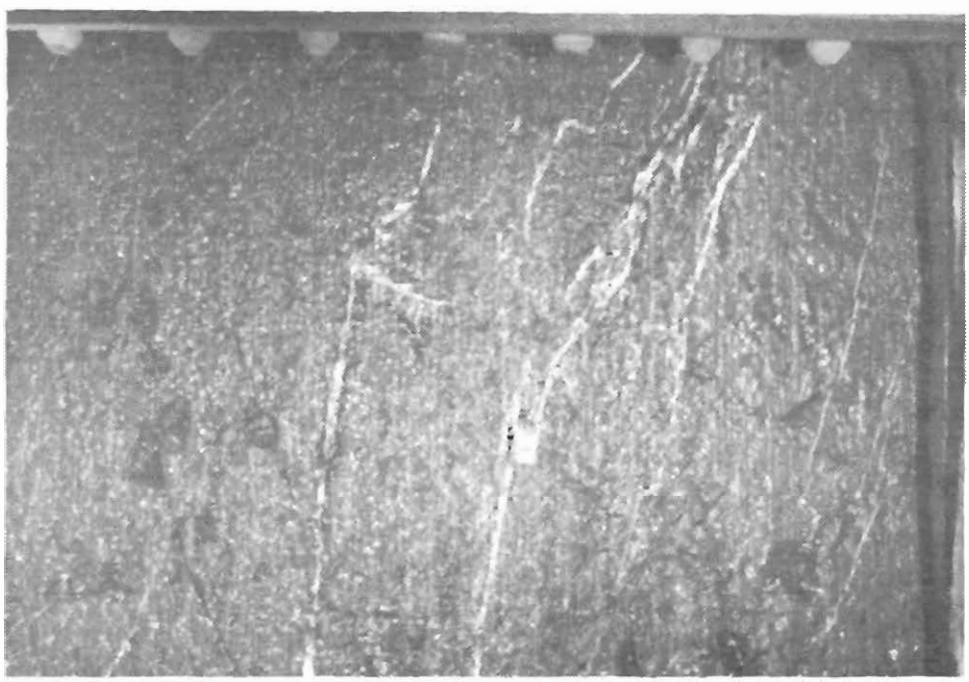
PHOTO I-8 Gray bedrock where the geologic origin and lithological type cannot be visually identified. Calcite-healed stringers appear near vertical and somewhat parallel. Photo obtained at Station 86+76.

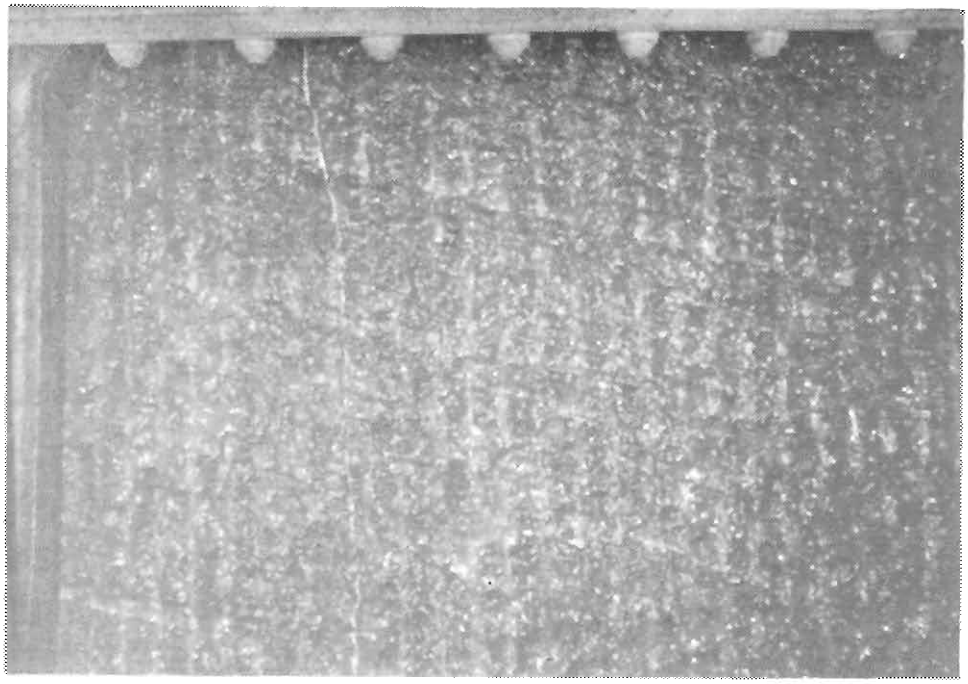
PHOTO I-9 Red shale with closely spaced near-vertical striations due to gage cutter. Photo obtained at Station 23+36.

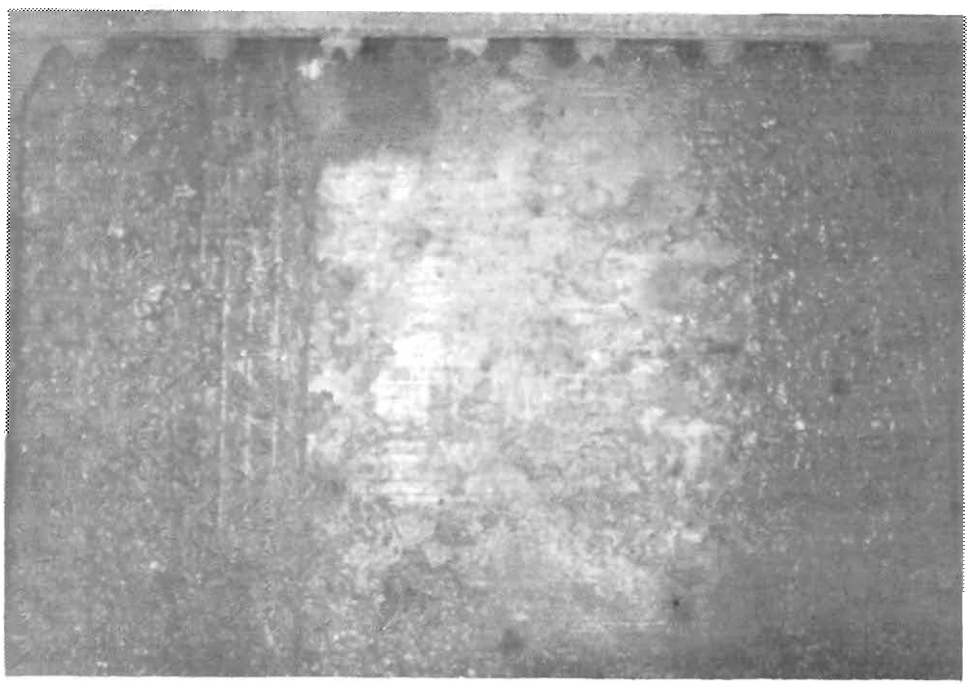
PHOTO I-10 Muck smeared against the tunnel wall. Several gage cutter striations appear to the left of the smeared material. Photo obtained at Station 45+06.

PHOTO I-11 Red shale exhibiting overbreak. The dimensions of the overbreak are approximately 18-in.-long, 9-in.-high, and perhaps 6-in.-deep. Photo obtained at Station 15+62.

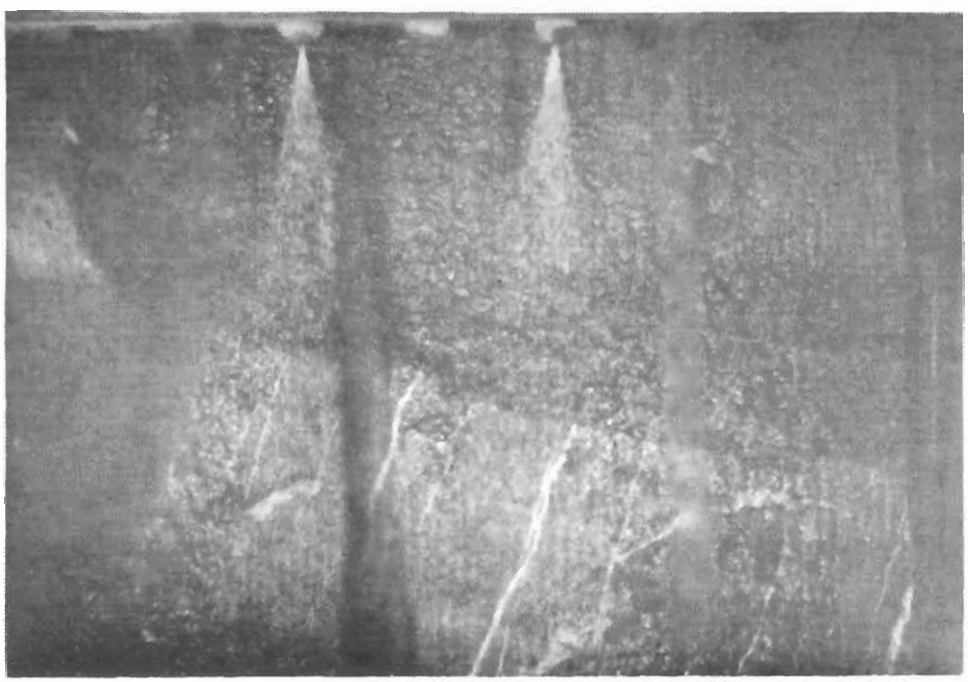
PHOTO I-12 Bed of sandstone in contact with red shale. The sandstone exhibits crossbedded jointing which has been calcite healed. The third and fifth water jets are washing the fines from the exposed bedrock surface revealing greater detail. Photo obtained from Station 72+44.

PHOTO I-13 The exposed bedrock appears interbedded. However, the glass between the camera and bedrock has been blurred by condensation preventing lithologic identification. Photo obtained at Station 19+69.

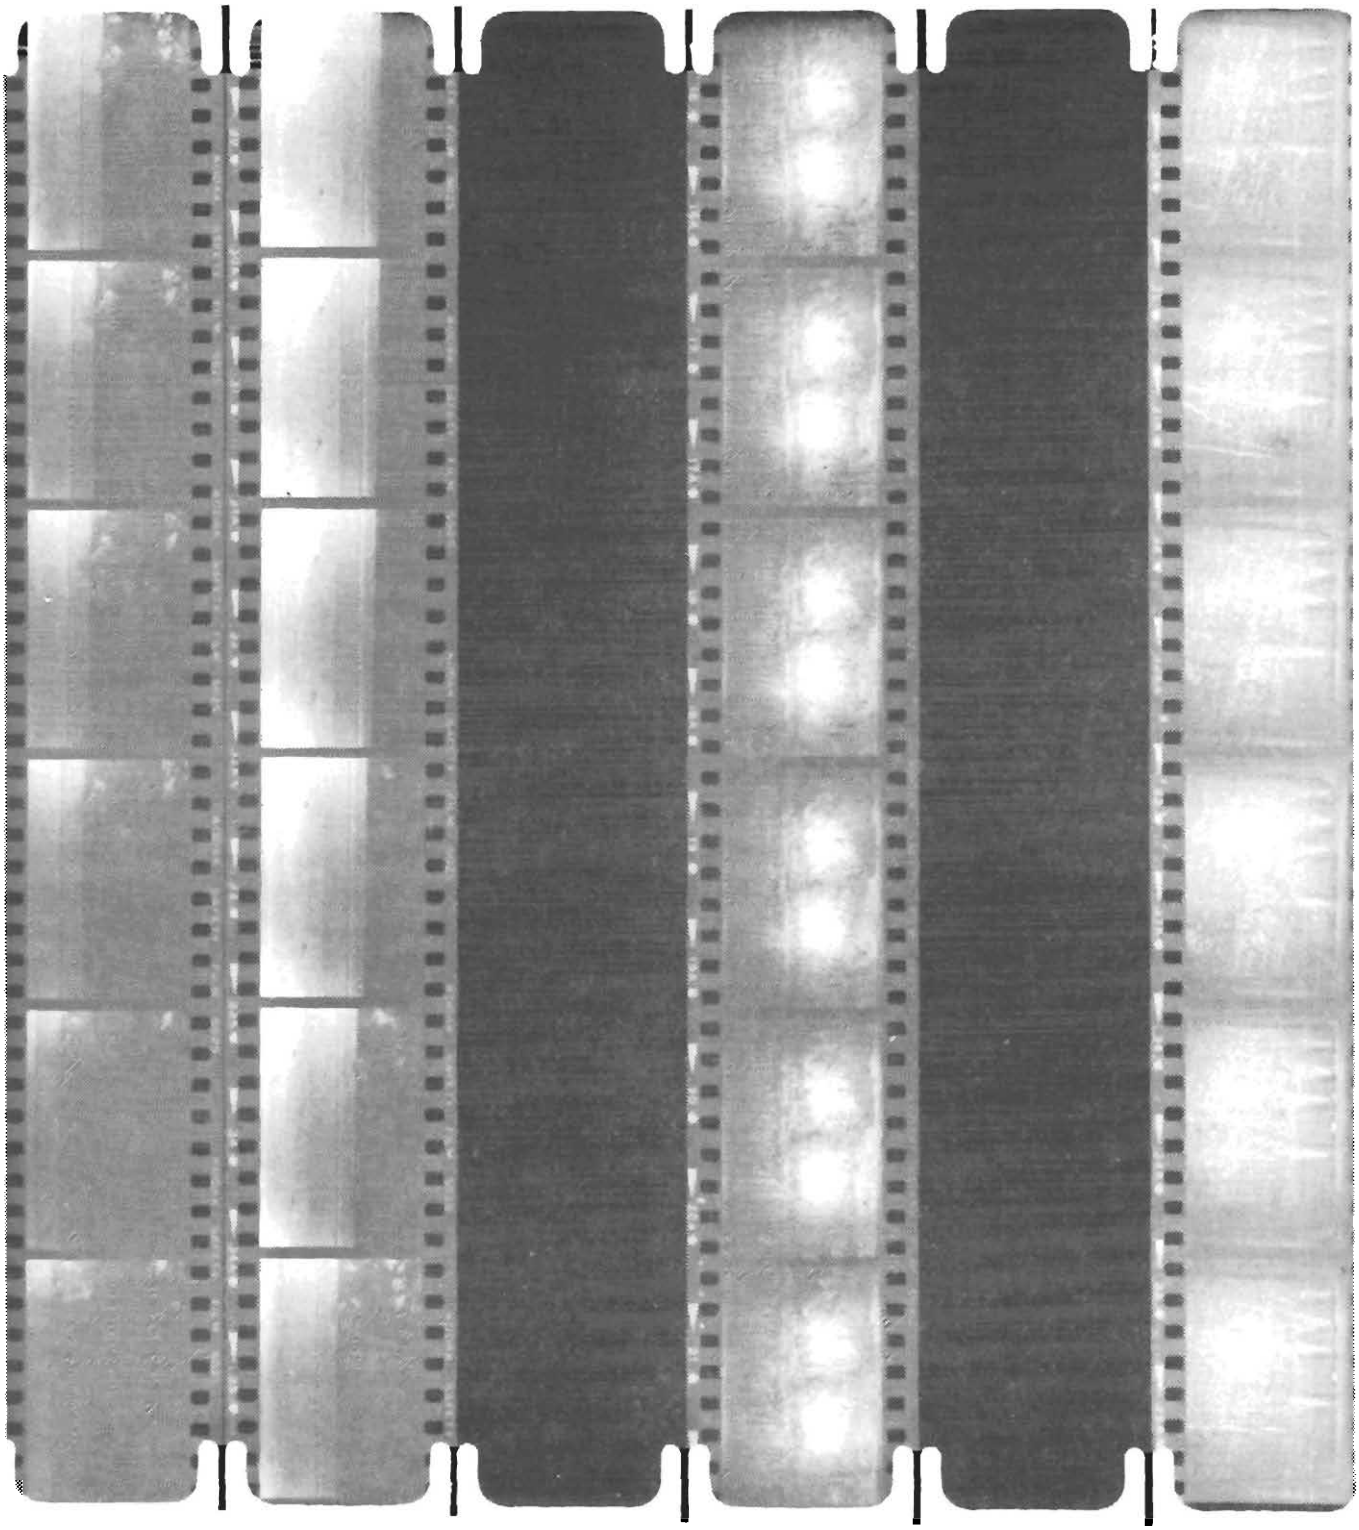
PHOTO I-14

An additional characteristic related to the system was exposures of the hydraulically operated door protecting the camera between exposures. In two separate instances the mount providing the reaction for the cylinder which opens the door (see Fig. 34) failed for unknown reasons and resulted in a series of exposures of the door (see Photo I-14B). The first occurrence went undetected for approximately one week and was repaired shortly thereafter. In the process of repairing the mount, the hydraulic hoses were disconnected from the cylinder and later connected in reverse order resulting in the door remaining open between exposures and closing immediately before an exposure was taken. This error produced a series of exposures of the door and was detected and repaired in approximately one week. Another circumstance involving an electrical malfunction also produced a series of exposures of the door. When the contact sheets for the last roll of film were examined, an interesting occurrence was observed (see Photo I-14C). Apparently, when the TBM encountered the fault zone at approximately Sta 96+64 (heading station), the thrusting force of the TBM extruded some of the clay around the cutterhead and against the protective door. The clay then pushed the door down and fractured the glass between the camera and tunnel wall.

Top Contact Set 14A Exposed bedrock in this series appears to be interbedded sandstone with some crossbedded jointing which has been calcite-healed. Exposures 32 and 33 appear to be duplicates. Exposures 34 and 35 appear to be overlapped based upon the position of the calcite-healed crossbedded joint.

Lower Contact Sets 14C Appears to be a progressive series of exposures obtained while the clay outside the door is gradually forcing the door open and eventually fracturing the glass between the camera and exposed bedrock. Series taken at fault zone near Station 96 + 60.
